Inspection Report

Property Address:
100 Future Drive
Alexandria KY 41001

JC Home Inspections, LLC

Date: 10/31/2020	Time: 04:30 PM	Report ID: 30260*WEB
Property: 100 Future Drive Alexandria KY 41001	Customer: Jane & John Doe	Real Estate Professional:

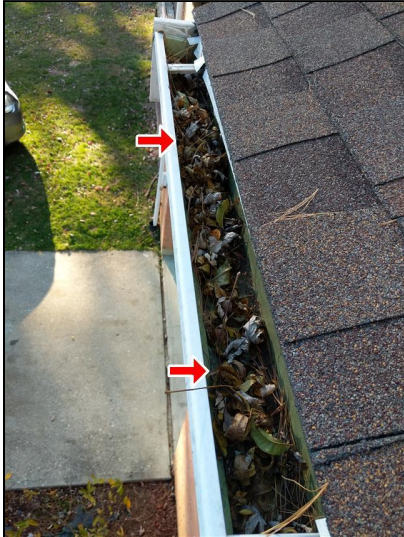
1.4 The gutter over the front of the house is full of debris, which can prevent proper water drainage. Debris can also add weight to the gutters, thus causing the gutters to pull away from the house. Recommend cleaning the gutter as needed.

1.4 Item 1(Picture) Debris in gutter

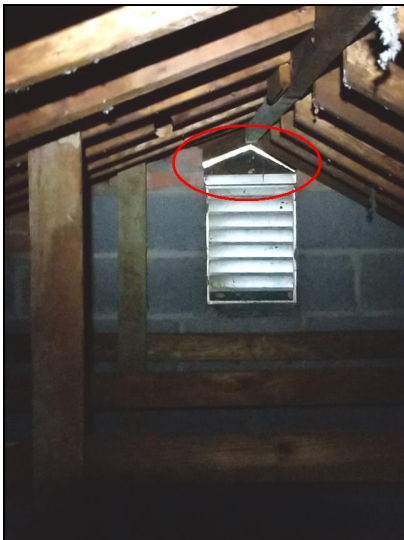
1.5 There is a gap over the passive vent on the right side of the house. Recommend sealing the gap to prevent the harborage of pests into the house.

1.5 Item 1(Picture) Gap over passive vent

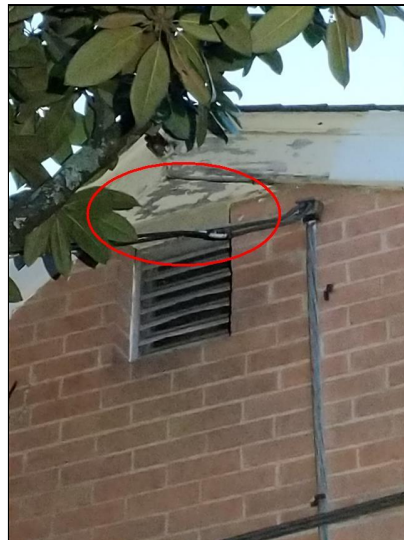
1.5 Item 2(Picture) Location of gap

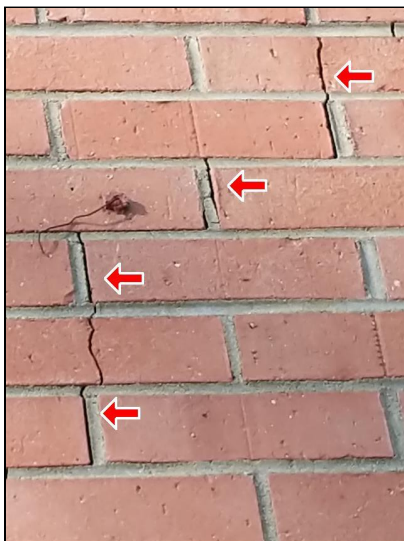
2.0 (1) There is a stair-step crack in the brick and mortar at the front of the house. The crack appears to be the result of settlement over time. Recommend a qualified company evaluate the movement of the wall, and recommend repair options.

2.0 Item 1(Picture) Stair-step crack in brick and mortar, front of house

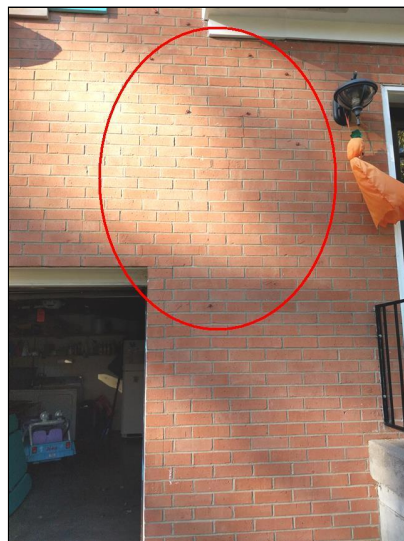
2.0 Item 2(Picture) Location of crack

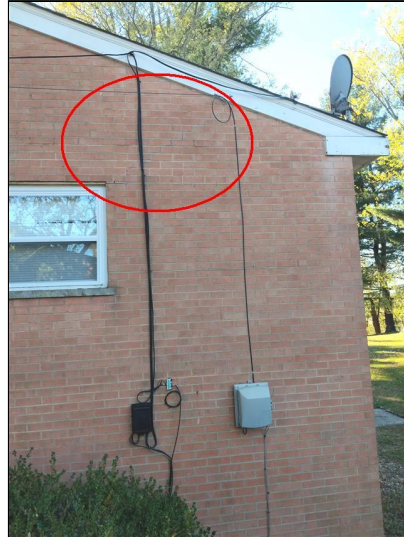
(2) There is a stair-step crack on the right side of the house. The crack has been repaired, however, the repairs appear to be failing. Recommend a qualified company evaluate the area for movement, and repair as needed.

2.0 Item 4(Picture) Location of crack

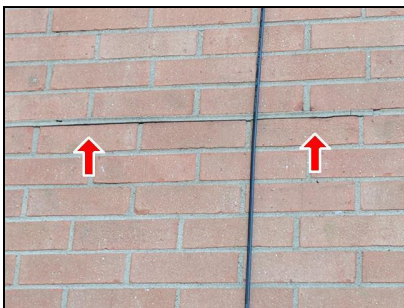
(3) The mortar is deteriorating at several locations around the house. Recommend a qualified person repair the damaged areas with an approved mortar, as needed.

2.0 Item 5(Picture) Mortar deteriorating on right side

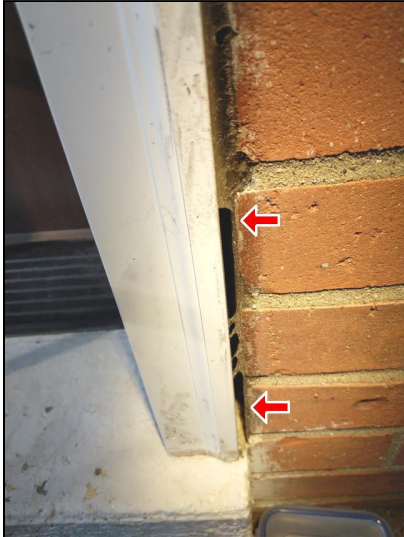
2.1 (1) There is a gap around the framing for the front entry door. Recommend sealing the gap with an approved silicone to prevent moisture intrusion.

2.1 Item 1(Picture) Gap at door frame, front of house

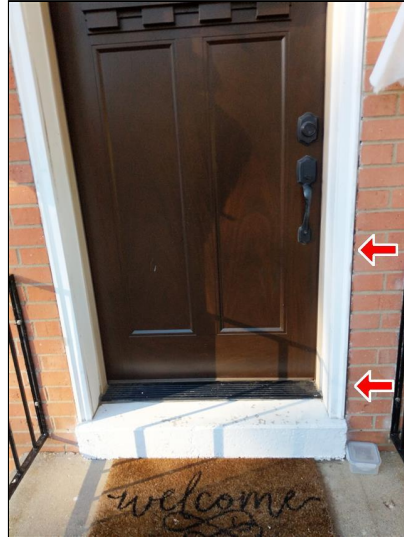
2.1 Item 2(Picture) Location of gap

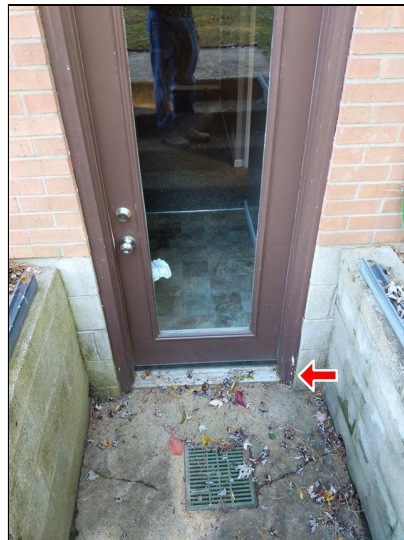
(2) There are signs of wood rot along the bottom framing for the basement entry door. Recommend a qualified person repair, prime, and paint the area as needed.

2.1 Item 4(Picture) Location of wood rot

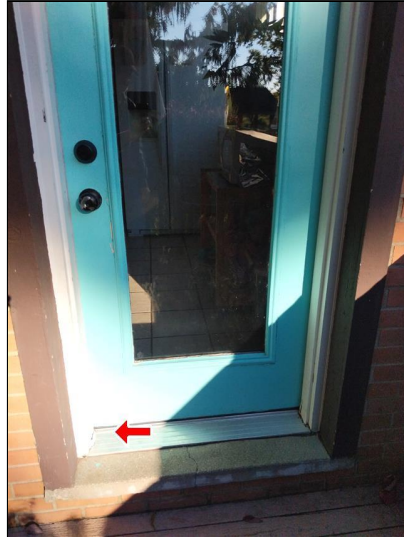
(3) There are signs of wood rot along the bottom framing for the left side entry door. Recommend a qualified person repair, prime, and paint the area as needed.

2.1 Item 6(Picture) Location of wood rot

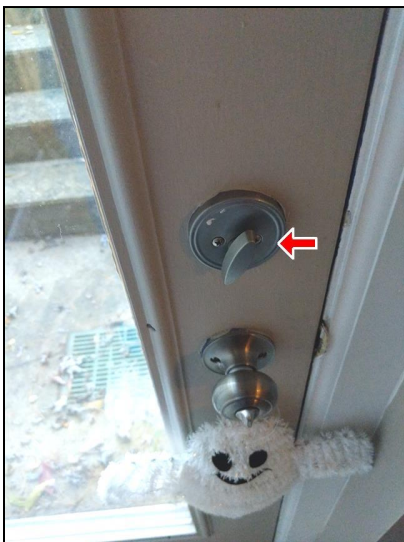
(4) The deadbolt for the basement entry door would not unlock. The knob just spins freely. Recommend a qualified person repair or replace the lock, as needed.

2.1 Item 7(Picture) Deadbolt will not open, rear entry door

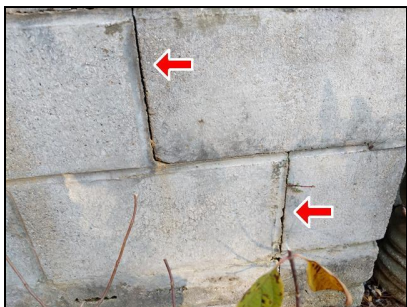
2.3 (1) There are several gaps in the mortar for the foundation under the front porch. Recommend a qualified person repair the damaged areas with an approved mortar sealant, as needed.

2.3 Item 1(Picture) Gaps in mortar at front porch

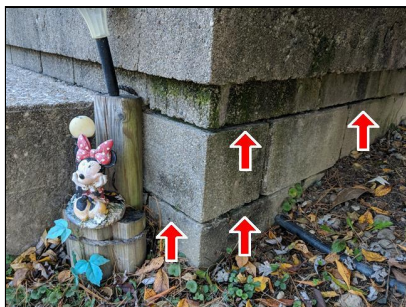
2.3 Item 2(Picture) Gaps in mortar at front porch

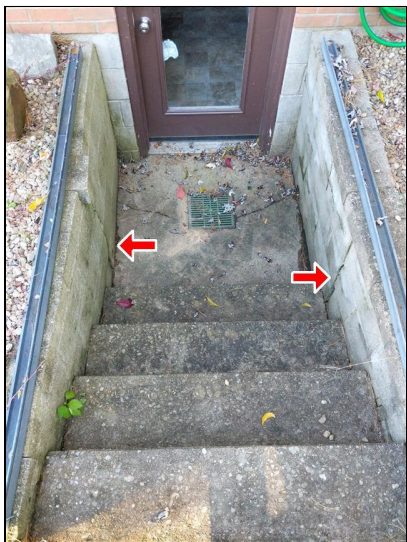
(2) The retaining walls for the basement steps are deteriorating. The walls are cracked, and are showing signs of inward movement. Recommend a qualified company evaluate the movement of the walls, and repair or replace as needed.

2.3 Item 3(Picture) Retaining walls damaged

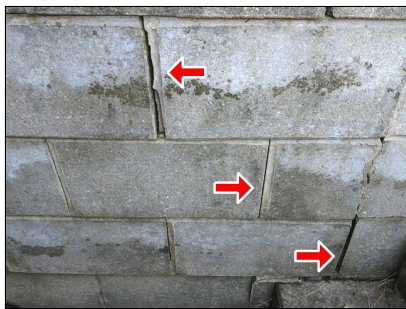
2.3 Item 4(Picture) Gap between blocks

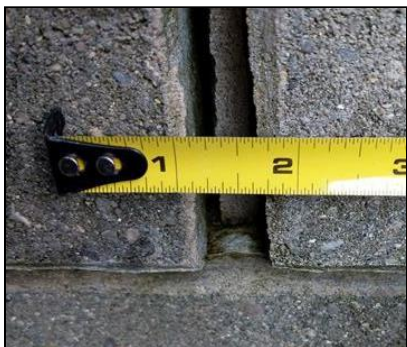
2.3 Item 6(Picture) Measurement of movement

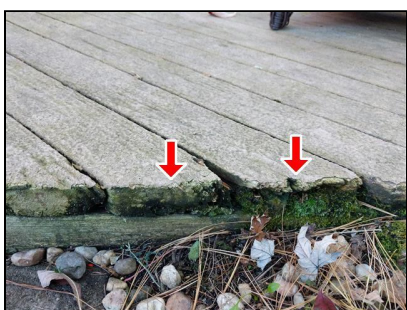
(3) Several of the deck floor boards are deteriorating. Recommend a qualified person replace the damaged floor boards, as needed.

2.3 Item 7(Picture) Deck boards deteriorating

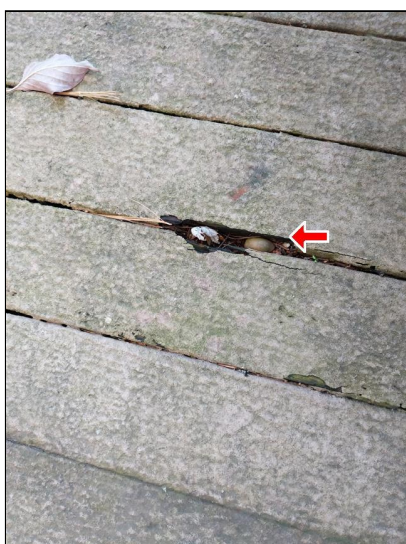
2.3 Item 8(Picture) Deck boards deteriorating

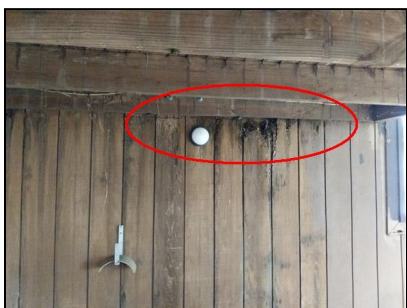
(4) The siding under the deck is showing signs of wood rot damage along the top edge. Several bird nests are present inside the damaged areas. Recommend a qualified person replace the damaged siding, as needed.

2.3 Item 9(Picture) Wood rot on siding under deck

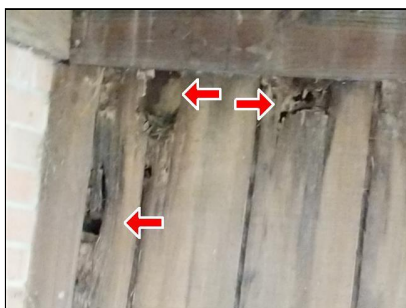
2.3 Item 10(Picture) Wood rot on siding

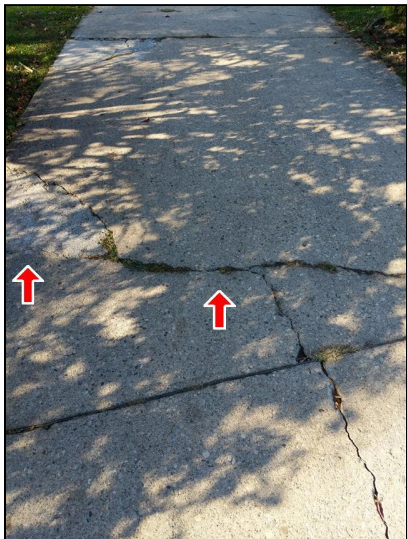
2.4 (1) The driveway is damaged at the front of the house. A damaged driveway can result in a trip hazard. Recommend a qualified person repair or replace the damaged driveway, as needed.

2.4 Item 1(Picture) Driveway damaged

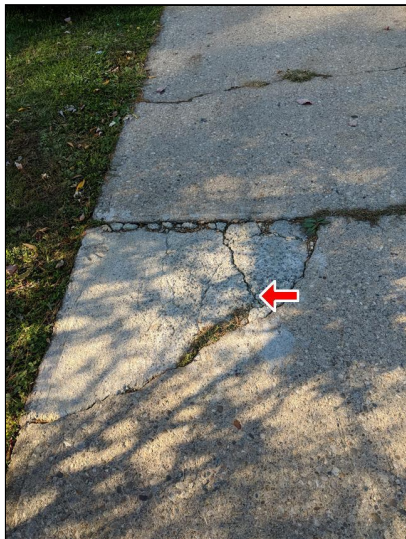
2.4 Item 2(Picture) Driveway damaged

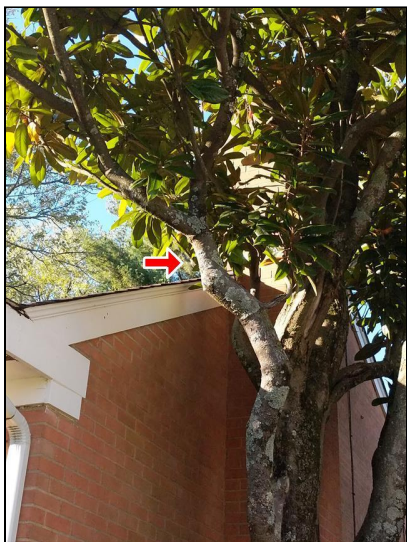
(2) The trees on both sides of the house are in contact with the walls. Vegetation that's in contact with the house can cause damage to the windows, walls and roof covering, if not corrected. Recommend trimming the vegetation away from the house, as needed, to prevent damage.

2.4 Item 3(Picture) Vegetation in contact with house

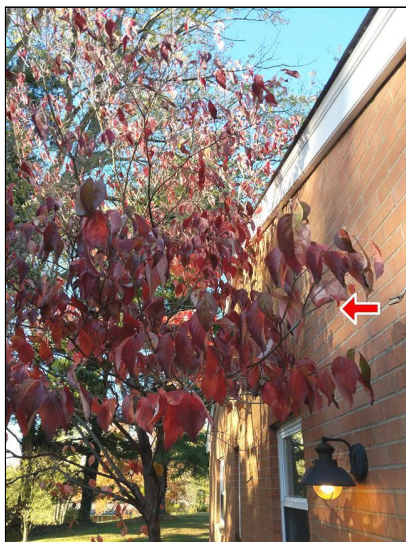
2.4 Item 4(Picture) Vegetation in contact with house

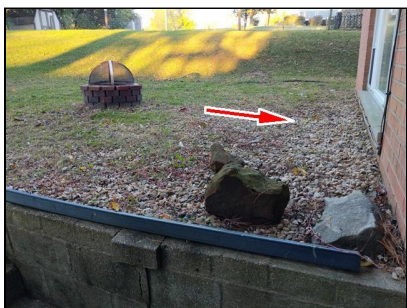
(3) The ground around the house is sloping toward the foundation wall at several locations. Improper grading can result in additional moisture along the foundation wall, thus leading to moisture intrusion into the house. Recommend adding dirt along the foundation wall to change the slope of the ground away from the house.

2.4 Item 5(Picture) Ground slopes toward foundation

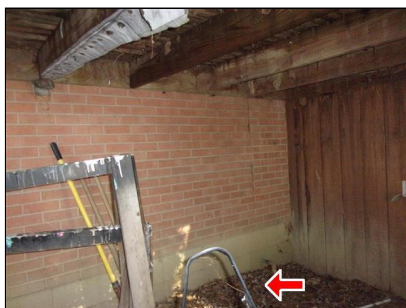
2.4 Item 6(Picture) Ground slopes toward foundation

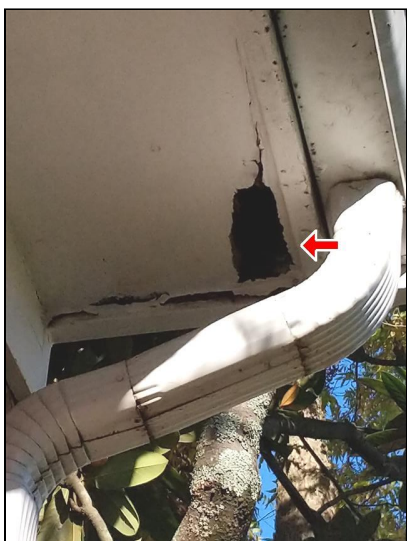
2.5 (1) There is a large hole in the soffit panel at the right, front corner of the house. Recommend sealing the hole to prevent the harborage of pests into the house.

2.5 Item 1(Picture) Hole in soffit panel, right front

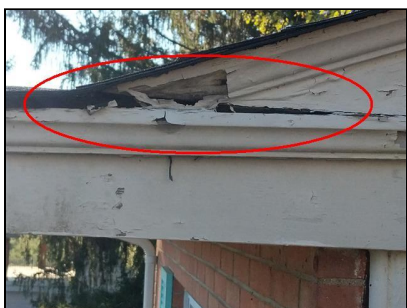
(2) There is a gap in the wood trim over the front porch. Recommend sealing the gap with an approved silicone to prevent moisture intrusion.

2.5 Item 2(Picture) Gap in wood trim over front porch

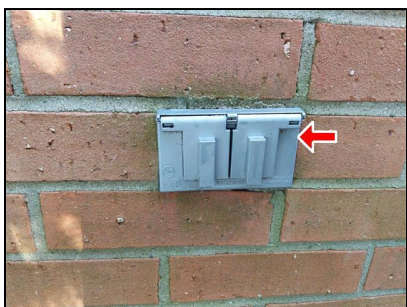
2.7 The exterior outlets are not GFCI protected. It is recommended that all exterior outlets, as well as any outlet within six feet of a plumbing fixture, be protected by a GFCI outlet. Recommend installing GFCI outlets as desired.

2.7 Item 1(Picture) Outlet not GFCI protected

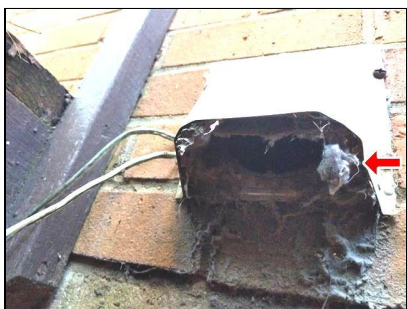
2.8 The dryer vent is full of lint, which is preventing the cover from closing properly. Recommend cleaning the vent to allow the cover to close as intended.

2.8 Item 1(Picture) Dryer vent needs to be cleaned

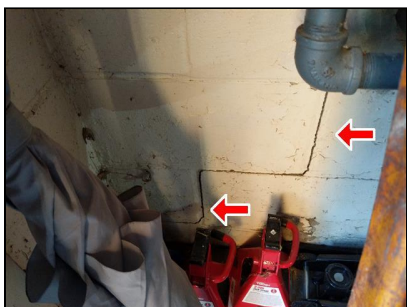
3.1 There is a stair-step crack in the left side wall of the garage. The crack is the result of settlement over time. Recommend a qualified company evaluate the movement of the wall, and repair as needed.

3.1 Item 1(Picture) Stair-step crack in garage wall, left side

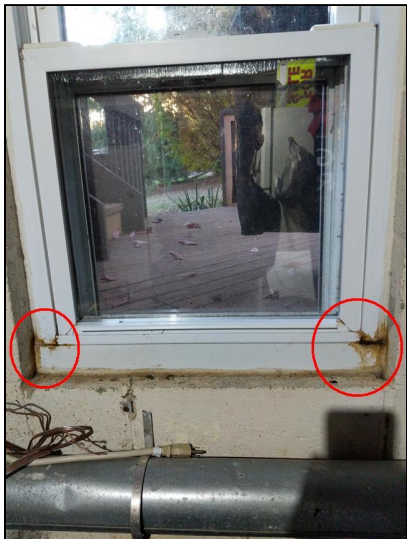
3.4 There are signs of moisture intrusion along the bottom edge of the window in the garage. At the time of the inspection, the area was dry. Recommend monitoring the area for future leaks, and repair as needed.

3.4 Item 1(Picture) Signs of moisture intrusion at garage window

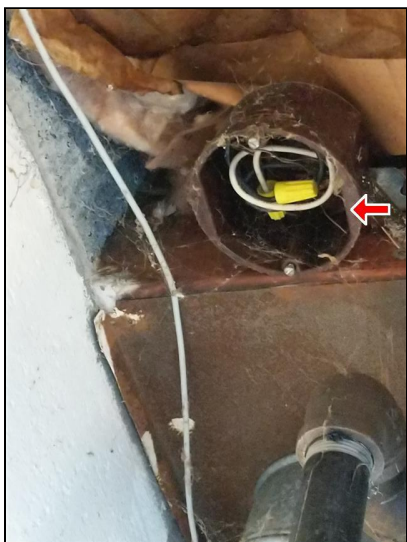
3.7 The cover plate is missing from the junction box in the ceiling of the garage. A missing cover allows wires to be exposed, which can cause injury. Recommend a qualified person replace the cover plate, as needed.

3.7 Item 1(Picture) Cover plate missing

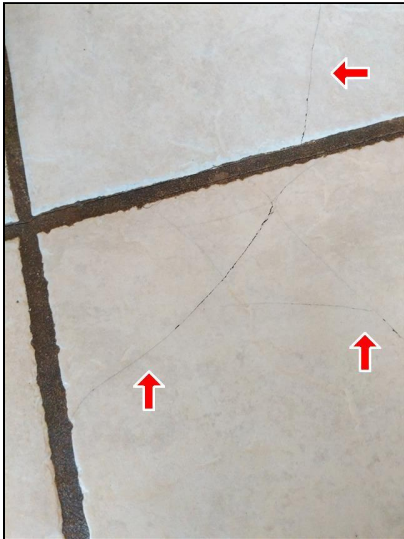
4.2 There are several damaged floor tiles in the kitchen. The damage appears to be cosmetic. Recommend replacing the damaged tiles, as needed.

4.2 Item 1(Picture) Floor tiles damaged

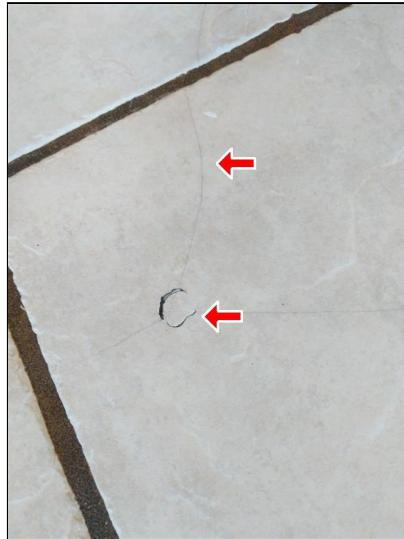
4.2 Item 2(Picture) Floor tiles damaged

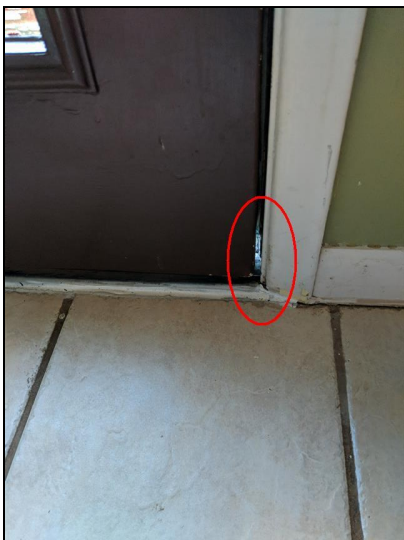
4.3 There is a gap along the bottom of the side entry door when closed. Recommend replacing the weather stripping to prevent a loss of energy.

4.3 Item 1(Picture) Gap at bottom of door when closed

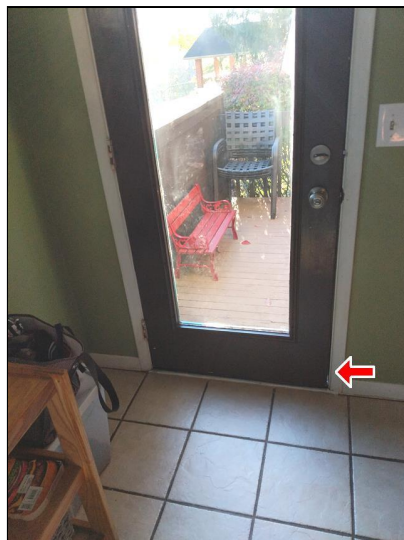
4.3 Item 2(Picture) Location of gap

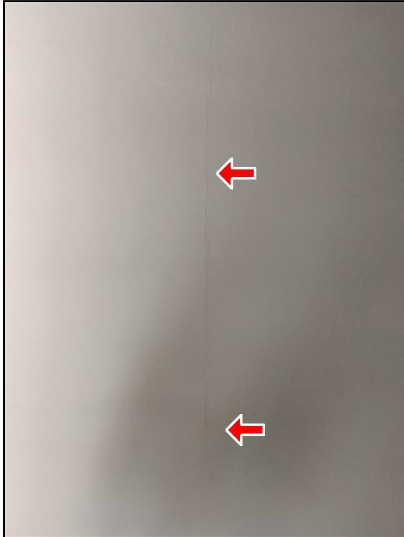
(2) There is a settlement crack in the ceiling of the living room. Recommend a qualified person repair, prime, and paint the area as needed.

5.0 Item 5(Picture) Crack in ceiling of living room

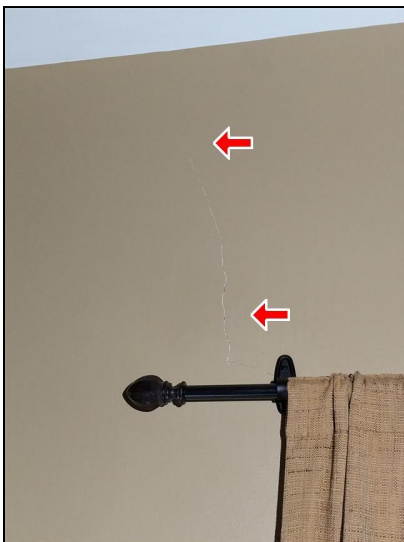
5.1 There is a settlement crack in the wall of the living room. Recommend a qualified person repair, prime, and paint the area as needed.

5.1 Item 1(Picture) Crack in wall of living room

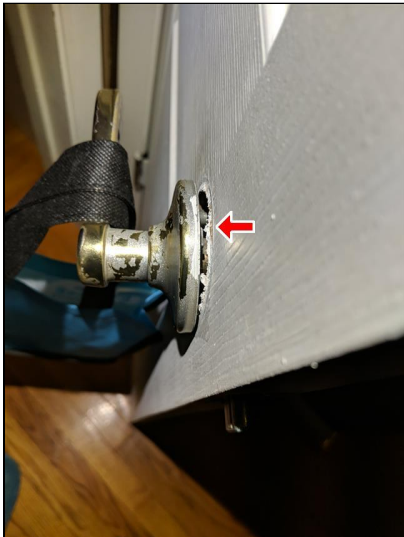
5.4 (1) The door handle for the hallway closet is loose. Recommend securing the loose handle, as needed.

5.4 Item 1(Picture) Door handle loose, hallway closet

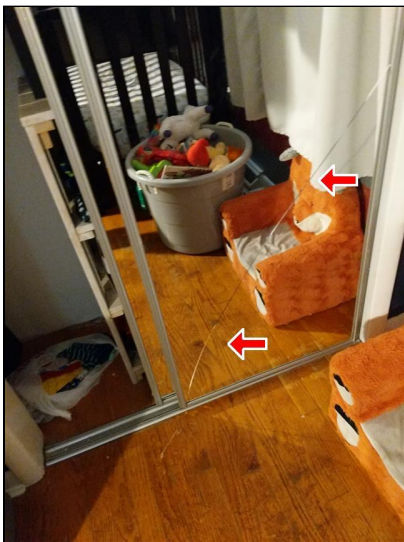
(2) The mirrored closet door in the left, rear bedroom is cracked. Recommend a qualified person replace the damaged door, to prevent injury.

5.4 Item 2(Picture) Crack in mirror on door, left rear bedroom

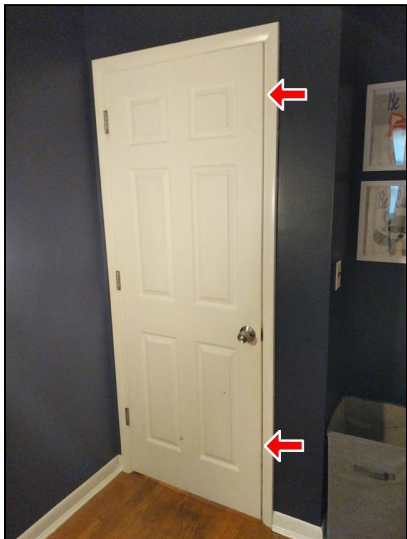
(3) The entry door for the left, rear bedroom sticks when closed. Recommend a qualified person adjust the door, as needed, to allow the door to close freely.

5.4 Item 3(Picture) Door sticks, left rear bedroom

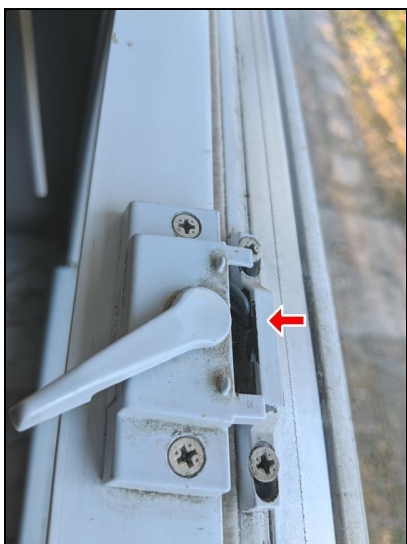
5.5 The left side lock for the window in the master bedroom is not properly aligned. This is preventing the lock from engaging. Recommend a qualified company evaluate the lock, and repair as needed.

5.5 Item 1(Picture) Window in master bedroom will not lock properly

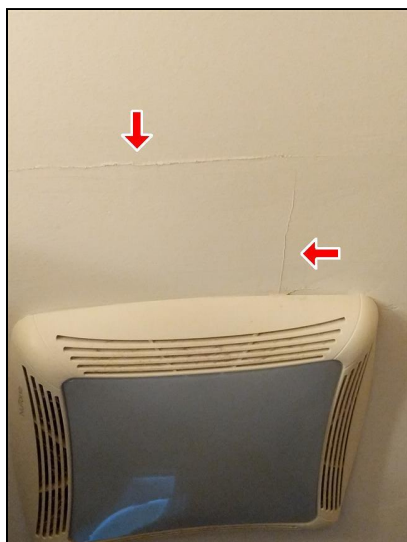
6.0 There is a crack in the ceiling of the first floor bathroom. The crack appears to be cosmetic. Recommend a qualified person repair, prime, and paint the ceiling as needed.

6.0 Item 1(Picture) Crack in ceiling

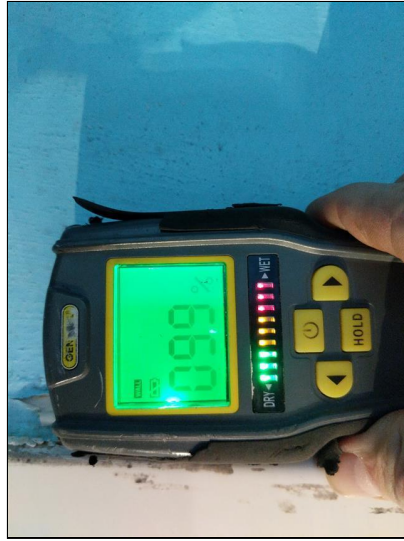
6.1 (1) There are signs of moisture intrusion on the wall over the shower in the basement. A moisture meter was used at this location, and readings of 99% and 86% (High) were recorded. The moisture appears to be the result of a gap over the electrical outlet on the exterior wall at this location. Recommend a qualified company evaluate the area for moisture intrusion, and repair as needed.

6.1 Item 2(Picture) Moisture meter reading

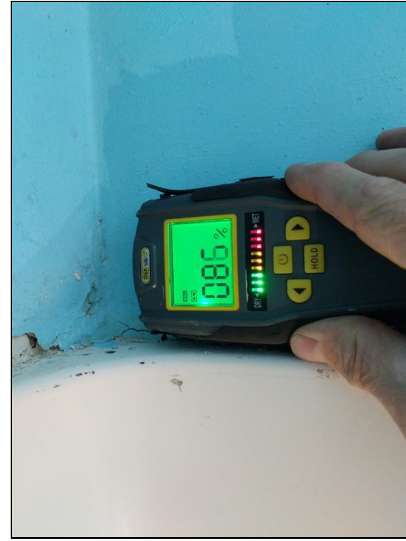
6.1 Item 3(Picture) Moisture meter reading

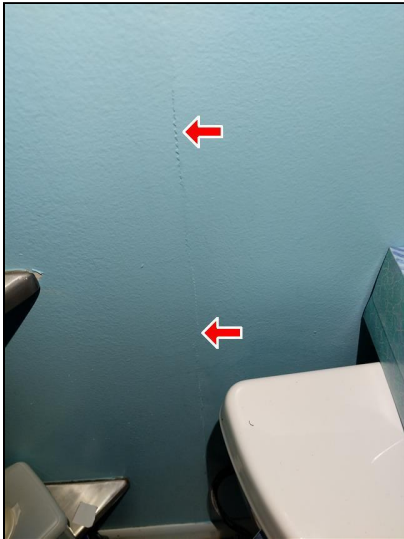
(2) There is a crack in the wall behind the toilet in the basement bathroom. The crack appears to be cosmetic. Recommend a qualified person repair, prime, and paint the area as needed.

6.1 Item 5(Picture) Crack in wall behind toilet

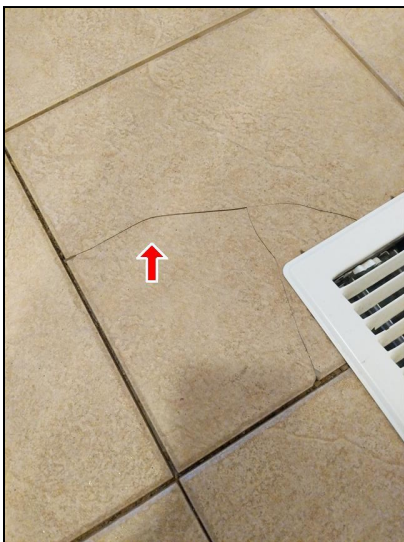
6.2 There are several floor tiles damaged in the first floor bathroom. The damage appears to be cosmetic. Recommend replacing the damaged tiles, as needed.

6.2 Item 1(Picture) Floor tiles damaged

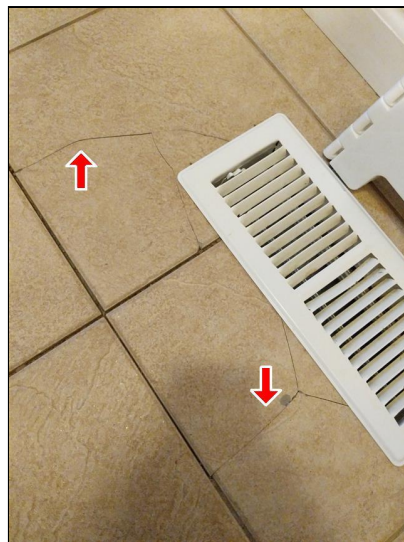
6.2 Item 2(Picture) Floor tiles damaged

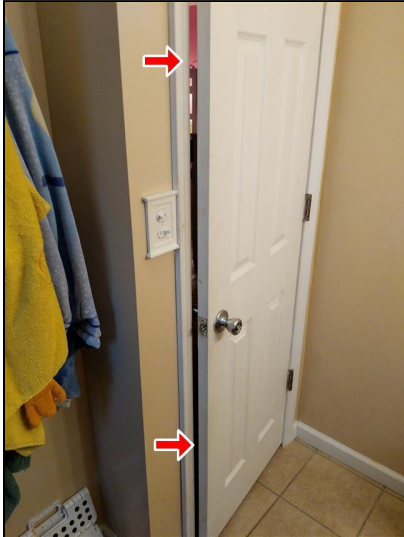
6.3 The entry door for the first floor bathroom sticks when closed. Recommend a qualified person adjust the door, as needed, to allow the door to close freely.

6.3 Item 1(Picture) Door sticks when closed

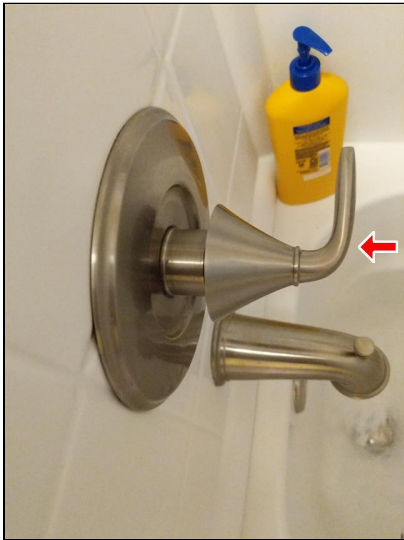
6.7 (1) The handle for the bathtub on the first floor is hard to turn. This is just for your information.

6.7 Item 1(Picture) Handle hard to turn

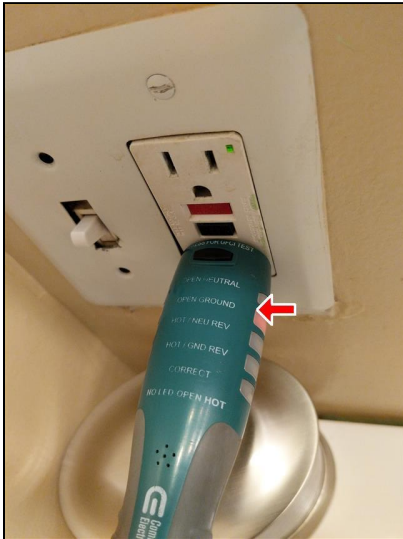
6.8 The GFCI outlet in the first floor bathroom is a nongrounded outlet. This is currently acceptable, however, the outlet should be labeled as a nongrounded GFCI outlet for safety. Recommend a qualified person label the outlet, as needed.

6.8 Item 1(Picture) GFCI outlet not grounded

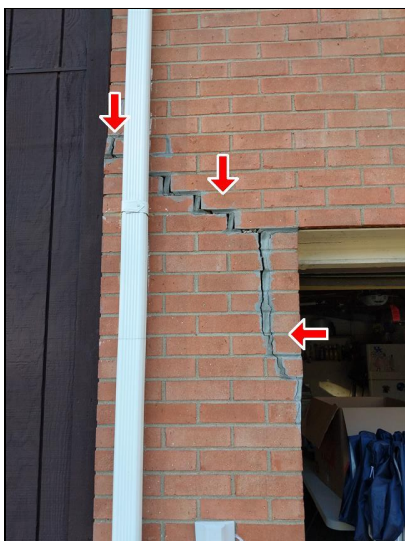
7.1 There is a large crack in the foundation wall on the left, front corner of the house. Several repairs have been attempted, however, the repairs appear to be failing. The lower section appears to have shifted outward approximately 1 inch. I cannot determine when the cracking occurred, or if the wall is still moving. Cracks greater than 1/8 inch indicate structural movement. Therefore, I recommend a qualified structural engineer, or foundation specialist, evaluate the movement of the wall, and recommend repair options.

7.1 Item 1(Picture) Foundation movement, left front

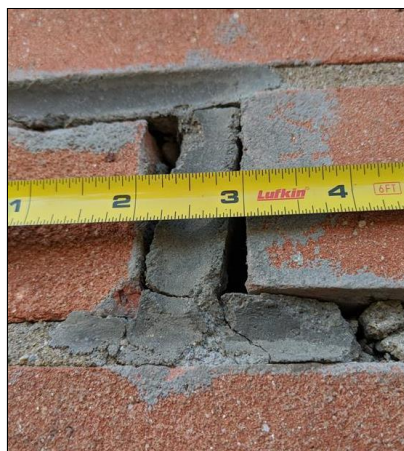
7.1 Item 2(Picture) Measurement of movement

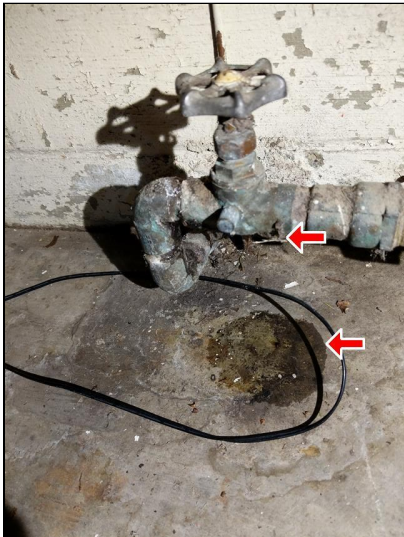
8.1 (1) There is a slow leak in the main water shut-off valve. Recommend a qualified plumber repair the leak, as needed.

8.1 Item 1(Picture) Leak at main water shut-off valve

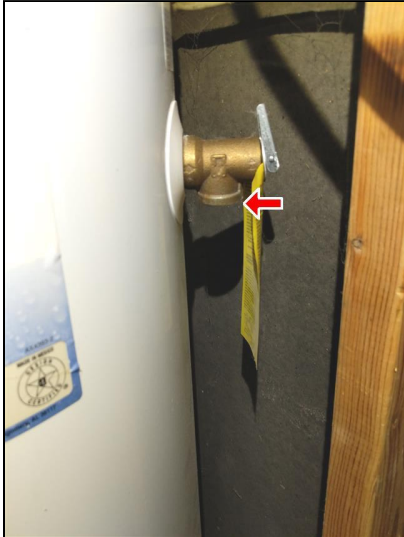
8.2 (1) The T&P (Test and Pressure) valve on the water heater needs a 3/4 inch threaded pipe to extend within 6 inches of the floor for safety. I recommend repair by a qualified person.

8.2 Item 1(Picture) T&P pipe missing

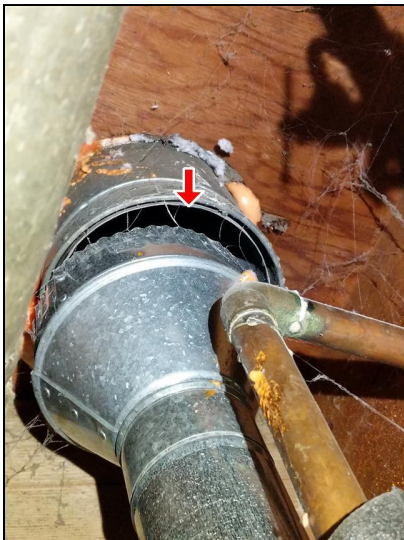
(2) The exhaust vent pipe for the water heater is disconnected just above the water heater. This can allow dangerous gases to exit the pipe into the house. Recommend a qualified person secure the pipe, as needed, to prevent injury.

8.2 Item 2(Picture) Vent not properly connected

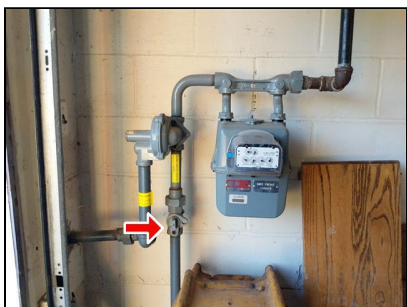
8.5 The main fuel shut-off is at the gas meter, which is located on the wall of the garage. This is just for your information.

8.5 Item 1(Picture) Main fuel shut-off

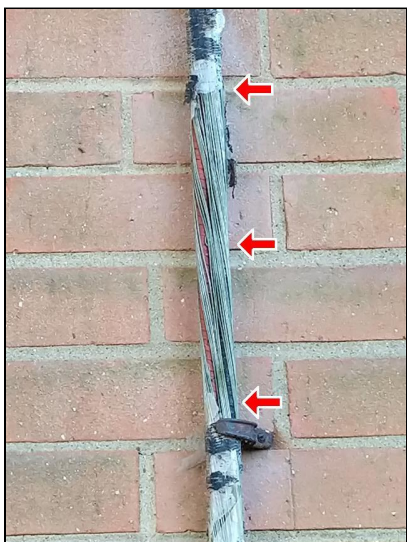
9.1 (1) The sheathing on the main electrical service line is deteriorating. Deteriorating sheathing can allow moisture to enter through the openings, thus causing damage to the electrical panel, or injury. Recommend a qualified electrician replace the damaged service line, as needed.

9.1 Item 1(Picture) Main service line deteriorating

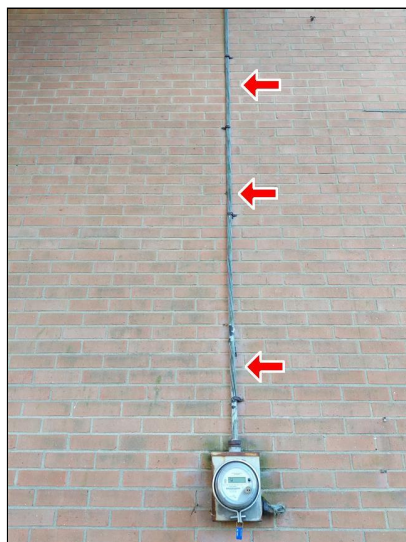
9.1 Item 2(Picture) Main service line deteriorating

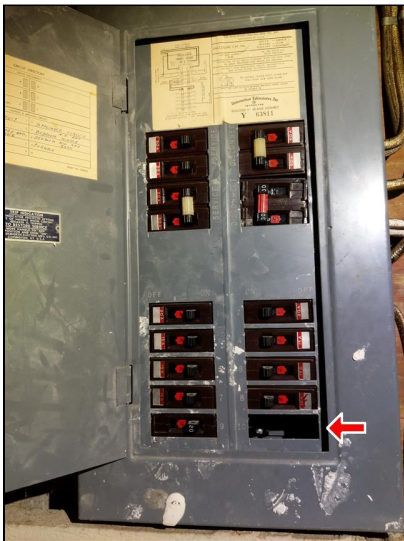
(3) There is a missing knockout cover on the right side of the electric panel. Missing knockout covers can allow an opening into the panel, which can allow contact with live wires. Recommend a qualified electrician install the missing knockout cover, as needed, to prevent injury.

9.1 Item 4(Picture) Knockout cover missing

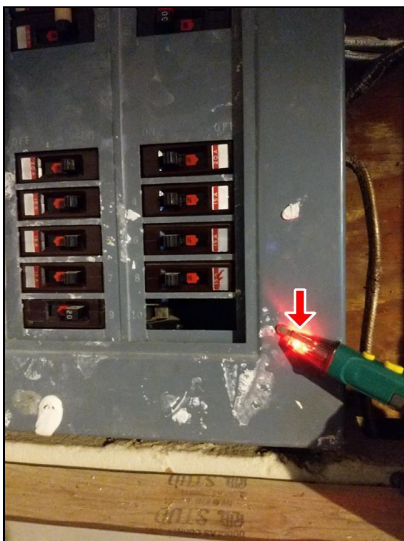
(4) At the time of the inspection, the electrical panel cover was indicating a live charge throughout. A charged electrical panel occurs when a live wire inside the panel comes in contact with the panel screws or housing. Electrically charged panels can cause injury, if not repaired. For this reason, the electrical panel was not fully inspected. Recommend a qualified electrician evaluate the entire electrical panel, and repair as needed.

9.1 Item 5(Picture) Panel charged

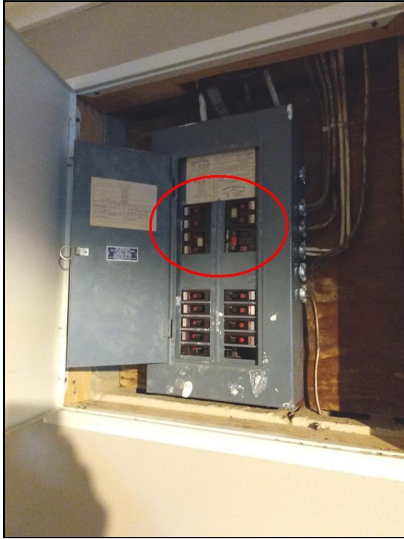
9.7 Item 1(Picture) Main electrical shut-off

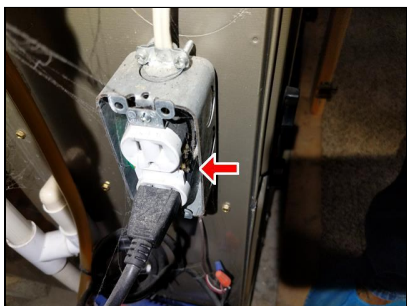
10.1 Item 1(Picture) Cover plate missing

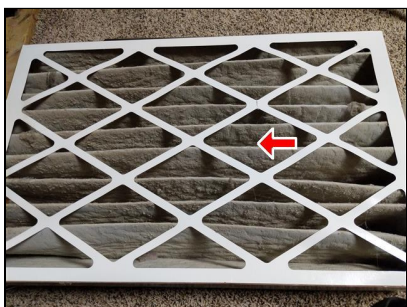
10.3 Item 1(Picture) Disposable air filter dirty

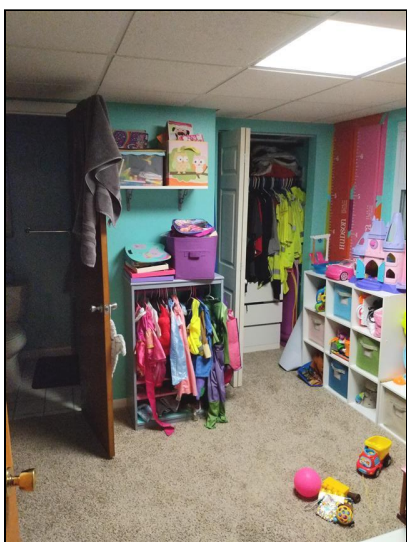
10.4 Item 1(Picture) No heat vent found in basement play area

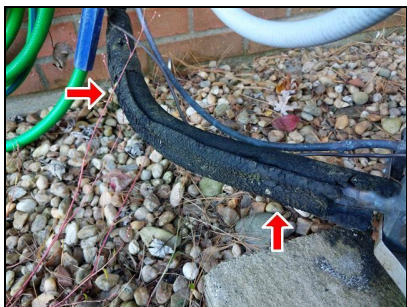
10.7 Item 1(Picture) Foam sleeve deteriorating

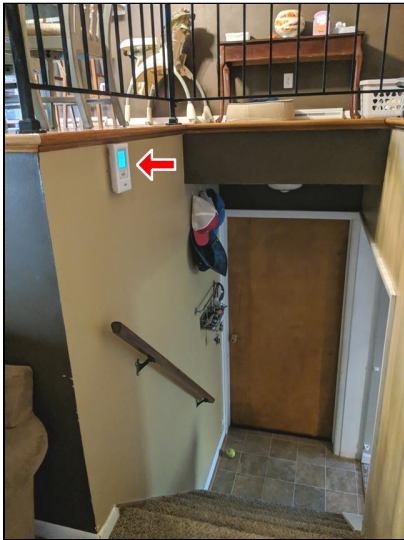
10.10 Item 1(Picture) Thermostat location
