Inspection Report

Property Address:
100 Future Drive
Alexandria KY 41001

JC Home Inspections, LLC

Date: 10/31/2020	Time: 04:30 PM	Report ID: 30260*WEB
Property: 100 Future Drive Alexandria KY 41001	Customer: Jane & John Doe	Real Estate Professional:

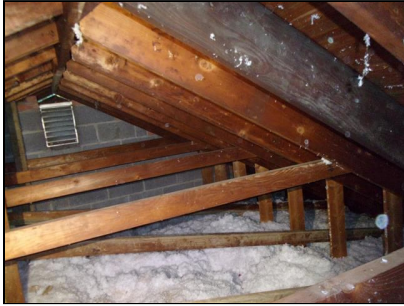
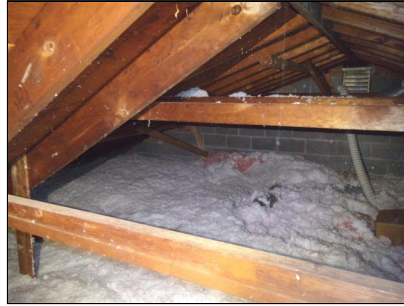
1.7 The insulation in the attic is about eleven inches thick, or just over an R-Value of 40. For this region, an R-Value of 38 or higher is recommended. This is just for your information.

1.7 Item 1(Picture) Attic insulation

1.7 Item 2(Picture) Attic insulation

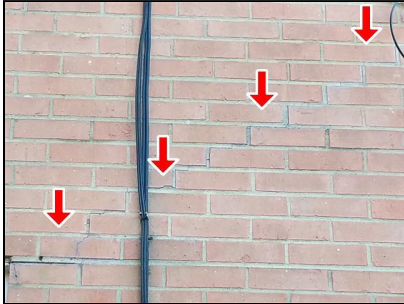
(2) There is a stair-step crack on the right side of the house. The crack has been repaired, however, the repairs appear to be failing. Recommend a qualified company evaluate the area for movement, and repair as needed.

2.0 Item 3(Picture) Stair-step crack, right side

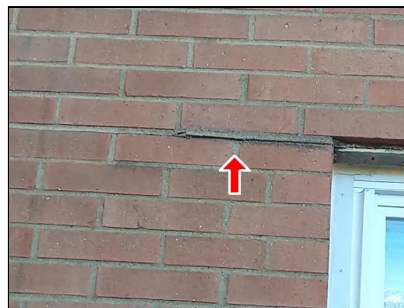
(3) The mortar is deteriorating at several locations around the house. Recommend a qualified person repair the damaged areas with an approved mortar, as needed.

2.0 Item 6(Picture) Mortar deteriorating on right side

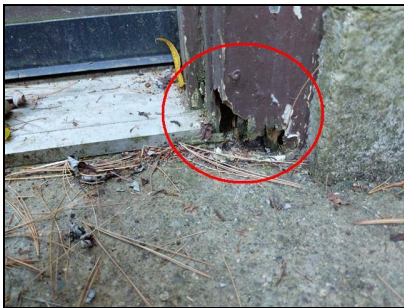
(2) There are signs of wood rot along the bottom framing for the basement entry door. Recommend a qualified person repair, prime, and paint the area as needed.

2.1 Item 3(Picture) Wood rot on door framing, rear of house

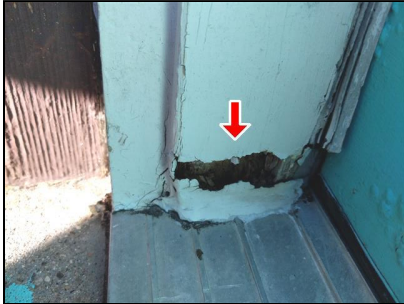
(3) There are signs of wood rot along the bottom framing for the left side entry door. Recommend a qualified person repair, prime, and paint the area as needed.

2.1 Item 5(Picture) Wood rot on door framing

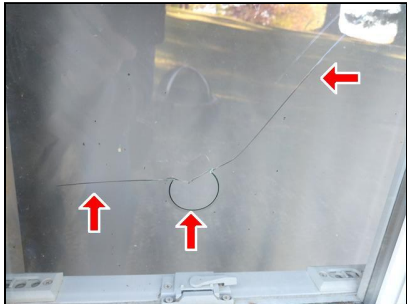
2.2 The window at the rear of the house is damaged. Recommend a qualified company replace the damaged glass to prevent injury.

2.2 Item 1(Picture) Window damaged at rear of house

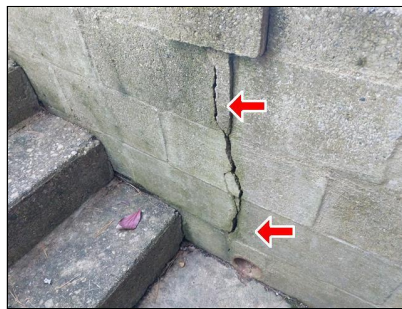
(2) The retaining walls for the basement steps are deteriorating. The walls are cracked, and are showing signs of inward movement. Recommend a qualified company evaluate the movement of the walls, and repair or replace as needed.

2.3 Item 5(Picture) Crack in wall blocks

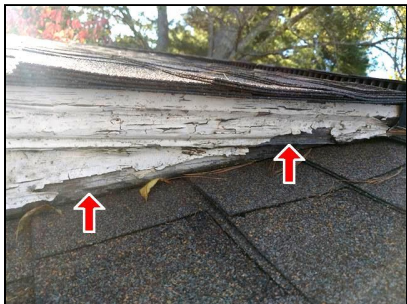
(3) The paint on the wood trim at the front of the house is peeling. Recommend a qualified person scrape, prime, and paint the area to prevent moisture damage to the exposed wood.

2.5 Item 3(Picture) Paint peeling on trim

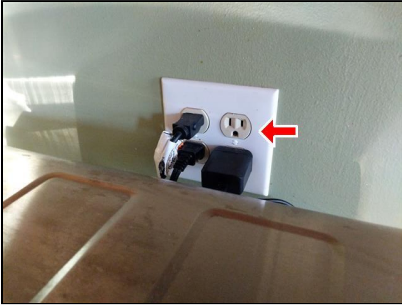
4.8 The outlets on the right side of the kitchen are not grounded. Outlets that are not grounded can cause damage to appliances during an electrical storm. Recommend the use of a surge protector at this location.

4.8 Item 1(Picture) Outlets not grounded

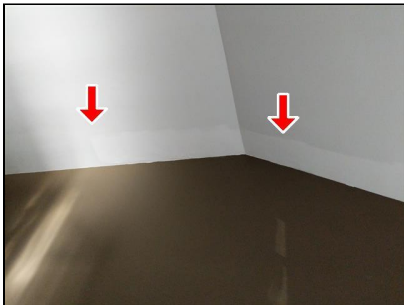
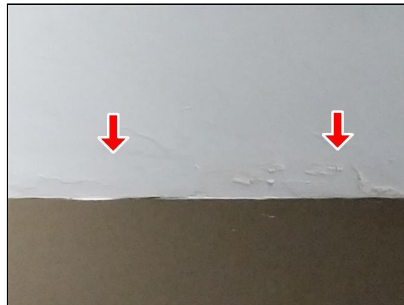
5.0 (1) There are moisture stains on the ceiling of the living room over the fireplace. A moisture meter was used at this location, and a reading of 55% (Medium) was recorded. Recommend a qualified roofer evaluate the seal around the chimney, and repair as needed.

5.0 Item 1(Picture) Moisture staining on ceiling above fireplace

5.0 Item 2(Picture) Moisture staining on ceiling

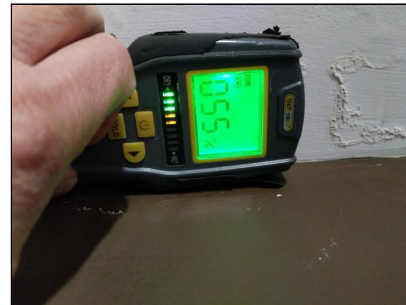
5.0 Item 3(Picture) Moisture meter reading

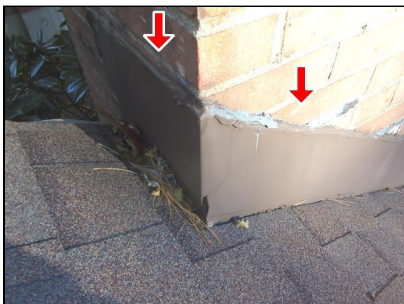
5.0 Item 4(Picture) Seal deteriorating around chimney

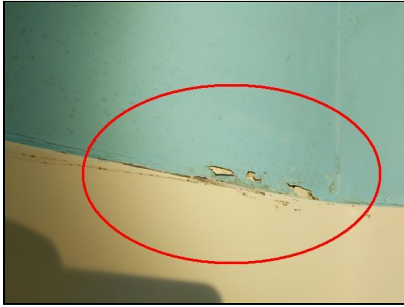
6.1 (1) There are signs of moisture intrusion on the wall over the shower in the basement. A moisture meter was used at this location, and readings of 99% and 86% (High) were recorded. The moisture appears to be the result of a gap over the electrical outlet on the exterior wall at this location. Recommend a qualified company evaluate the area for moisture intrusion, and repair as needed.

6.1 Item 1(Picture) Moisture damage on wall

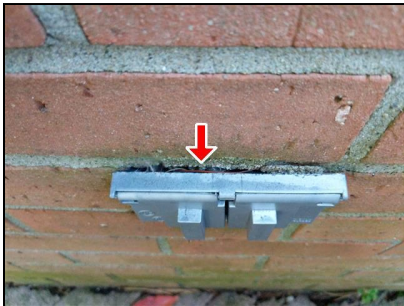
6.1 Item 4(Picture) Source of moisture intrusion

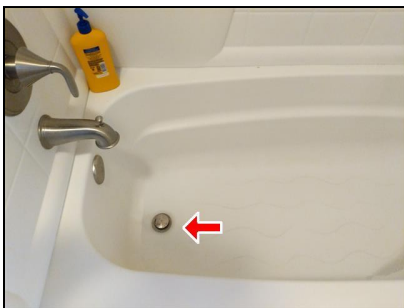
6.6 The bathtub on the first floor is slow to drain. Recommend a qualified person clean the drain, as needed, to allow the tub to drain as intended.

6.6 Item 1(Picture) Bathtub slow to drain

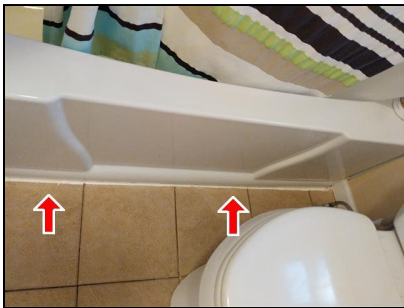
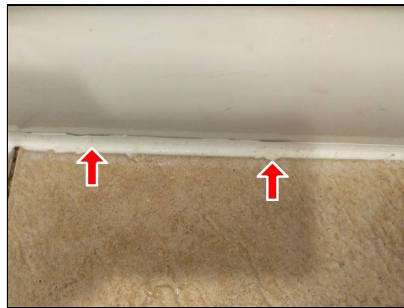
(2) The seal between the floor and bathtub is deteriorating in the first floor bathroom. A deteriorating seal can allow moisture to enter through the opening, thus causing damage to the ceiling below. Recommend a qualified person seal around the bathtub, as needed, to prevent damage.

6.7 Item 2(Picture) Seal deteriorating at floor

6.7 Item 3(Picture) Seal deteriorating

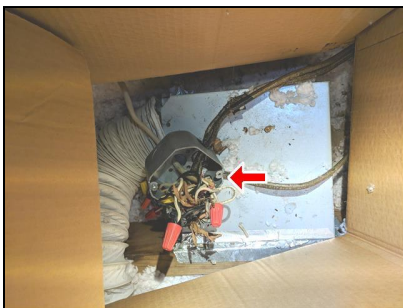
6.9 The cover plate is missing for the junction box that is located on top of the bathroom exhaust fan in the attic. Recommend a qualified person secure the wiring inside a closed junction box to prevent injury.

6.9 Item 1(Picture) Wires not properly secured

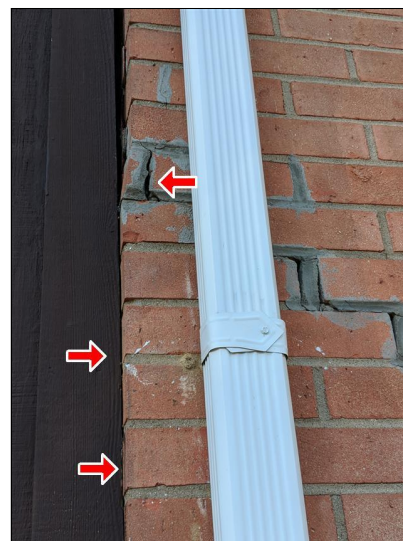
7.1 Item 3(Picture) Wall movement

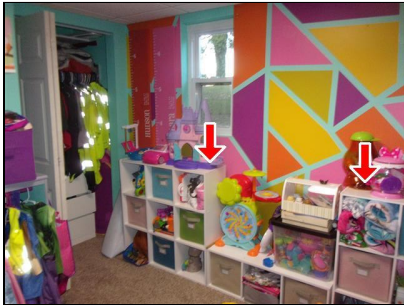
7.8 (1) Some areas of the lower level could not be fully inspected due to personal items being stored along the walls and floor. This is just for your information.

7.8 Item 1(Picture) Personal items stored along walls and floor

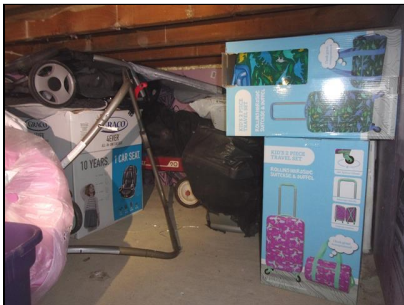
(2) Some areas of the crawlspace could not be fully inspected due to personal items being stored along the walls and floor. This is just for your information.

7.8 Item 2(Picture) Personal items stored in crawlspace

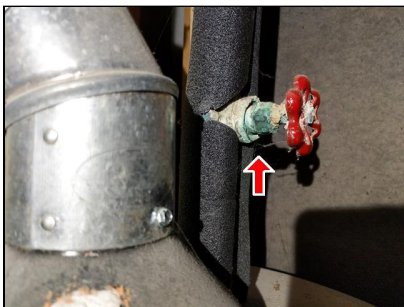
(2) There are signs of a prior leak at the shut-off valve over the water heater. At the time of the inspection, the valve was not leaking. Recommend monitoring the valve for leaks, and repair as needed.

8.1 Item 2(Picture) Prior leak at shut-off valve over water heater

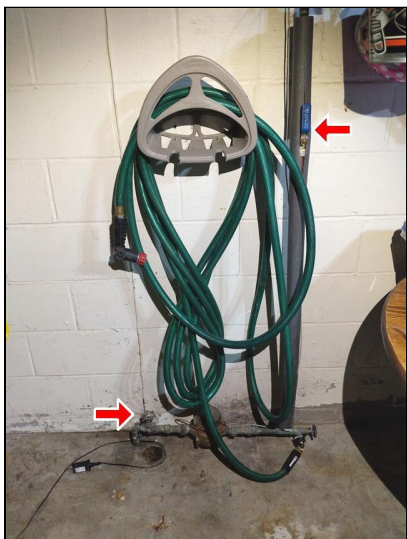
8.3 The main water shut-off is located on the wall of the garage. This is just for your information.

8.3 Item 1(Picture) Main water shut-off

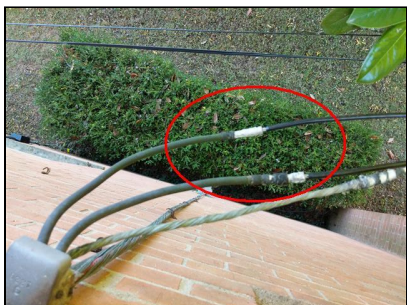
(2) The metal wire splice crimps on the main electrical service drop are not insulated. Missing insulators on these wire splices can cause injury. Recommend a qualified electrician install wire insulators over the service crimps, as needed.

9.1 Item 3(Picture) Insulators missing

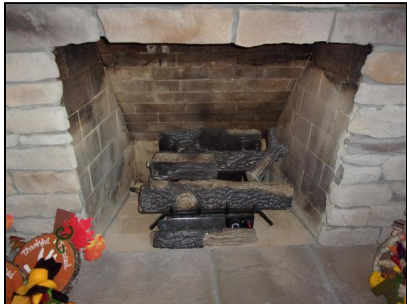
10.6 The gas fireplace is not vented. The flue pipes have been sealed off on top of the chimney. Recommend a qualified company evaluate the fireplace vent system, and recommend repair options.

10.6 Item 1(Picture) Gas fireplace

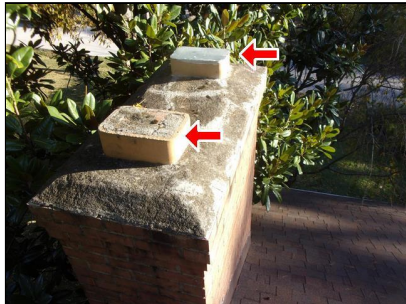
10.6 Item 2(Picture) Flue pipes sealed
